Horizon  
Hydrogène  
Energie

## ***Detection of MEA's flaws in PEMFC : “in-situ” Relaxometry combined with “ex-situ” Infrared Imagery***

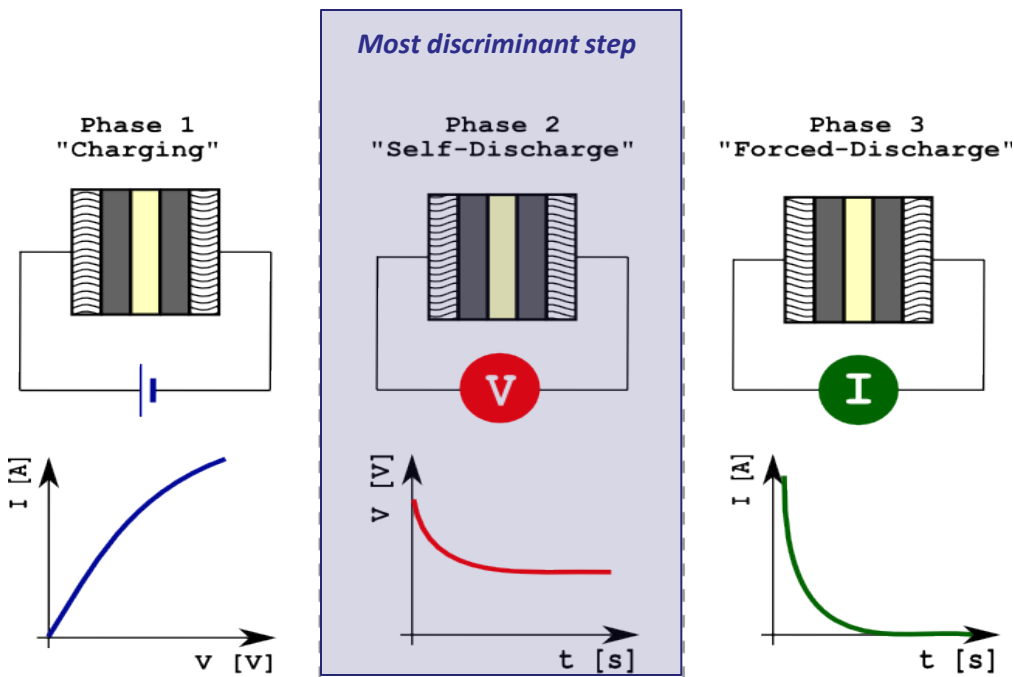
## □ Electrical relaxometry<sup>1</sup> (method)

**Passive state : No electrochemical reaction**

- ✓ *Integrated in Fuel Cell (current source and voltage measurement)*
- ✓ *Fast and synchronous measurement of all the cells*
- ✓ *Electrical short-cut growth detection*

- **Phase 1:** a forced charging – a current (few mA) is applied during few seconds
- **Phase 2:** a self discharge - the MEA is held at open circuit and freely discharges
- **Phase 3:** a forced discharge to return MEA at an equilibrium state

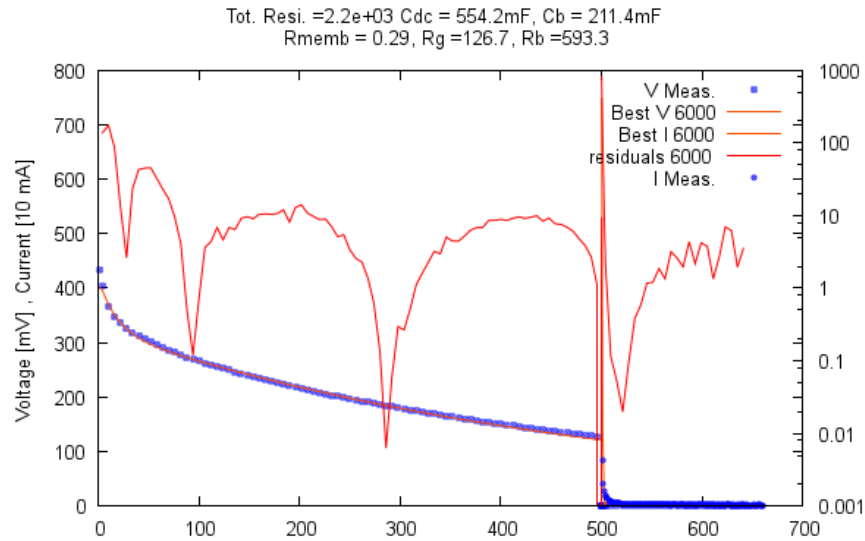
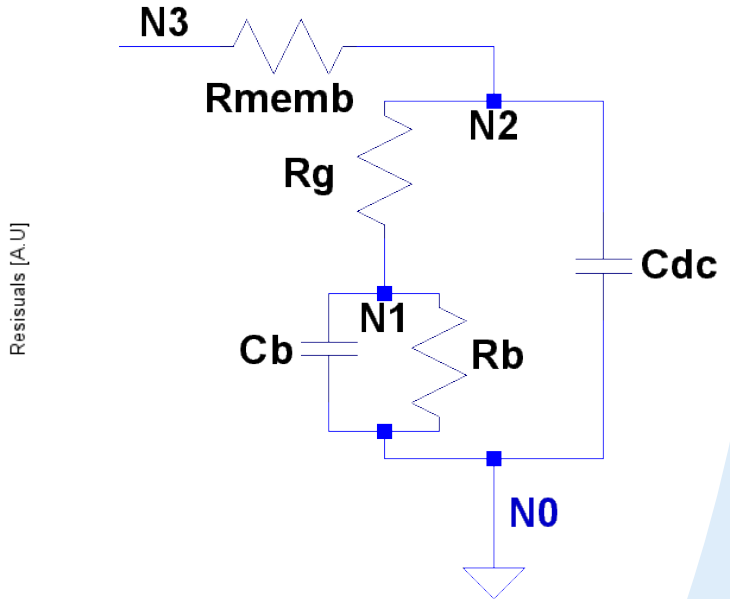
Kohlrausch (KWW) function simulated by a Monte Carlo numerical simulation

Equivalent circuit to fit the Phase 2

$$V(t) = V_{source} \left[ 1 - \exp\left(-\left(\frac{t}{\tau_c}\right)^\beta\right) \right]$$

*Rg, Rb related to electrical short-circuit*

**Estimation of  $R_{short-circuit}$  with data from phase 2**

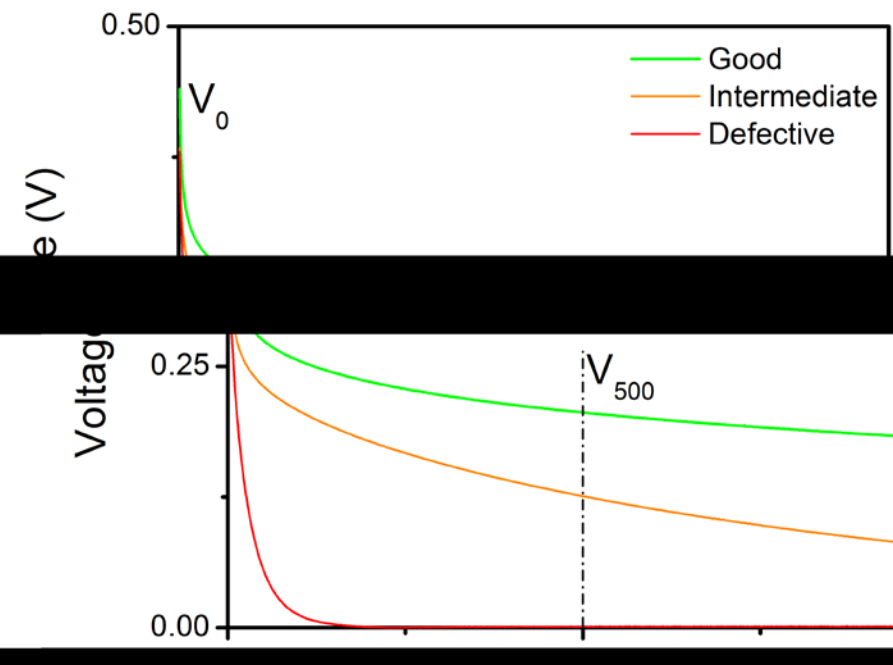
### Phase 2: the most discriminant step

- The self discharge of the  $D_{LC}$  is governed by the electrical short-circuit resistance
- Equilibrium recovery for an unaged MEA is approximately 10 hours
- A rapid drop of the voltage indicates a localized contact between the active layers

**Good** : No electrical short-circuit  
**Intermediate** : beginnings for short-circuit  
**Defective** : Evident short circuit within the cell

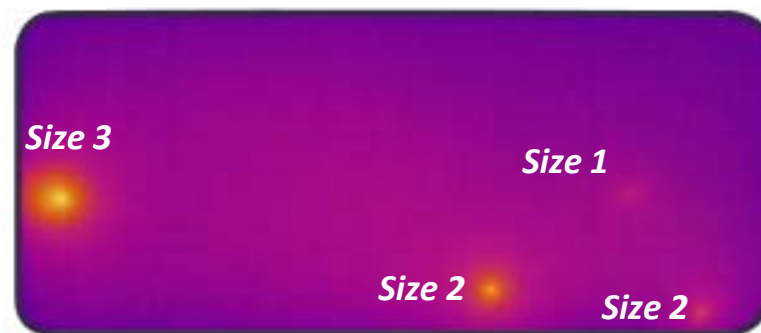
## Classification

Flaws classified as a function of the generated heat

$$\Delta T (\text{°C}) = T_{\text{max}} - T_{\text{min}}$$

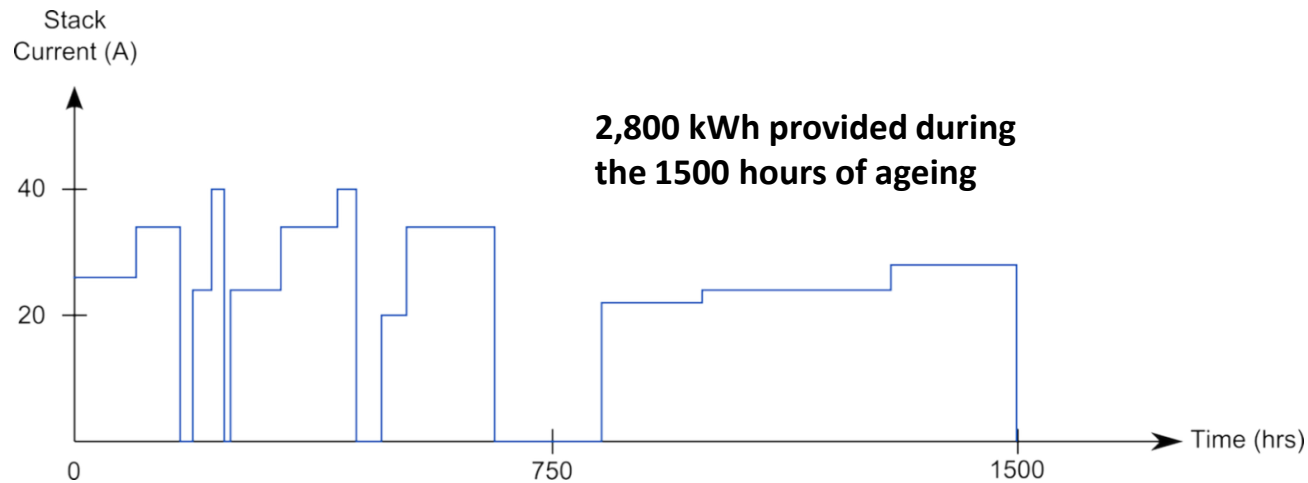
### • Load profile of the system studied and its specificity

***Shut down of the Fuel Cell due to unsafety level of H<sub>2</sub> leak***
